A composite sandwich plate with a novel core design

Abstract

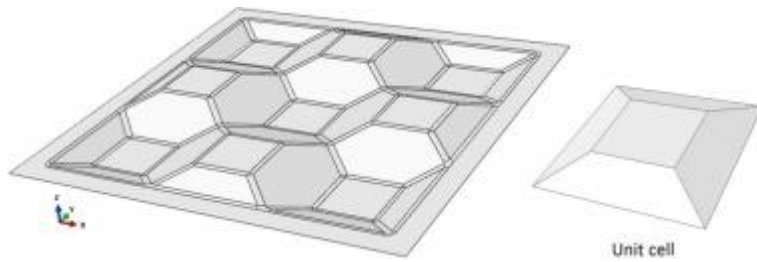
Fig. 1. The schematic representation of the core design introduced in this study and unit cell.

In this study, a new core design is introduced. The core consists of unit cells having a truncated pyramidal shape with a square base as depicted in Fig. 1. It is similar to an egg crate. It is composed of fiber-reinforced composite layers like the skins. Thickness and orientation of the layers, the size of the unit cell, the core thickness, and the wall angle define the geometric features of the core. It is possible to obtain numerous geometrical configurations by changing these parameters. One may optimize the geometric features for different loading conditions. The space may also be filled with foam to improve some physical properties for specific applications. Although this type of sandwich structure is more costly compared to honeycomb and foam core sandwiches, it is expected to show superior performance in the presence of transverse concentrated or distributed loads and shear loading. Unlike honeycomb cores, it can resist out-of-plane shear forces thanks to the angulated side faces and large contact surfaces. As opposed to corrugated ones, it provides high bending stiffness and strength in the two in-plane directions not only in one direction.

The base area of a unit cell of the core structure, which is depicted in Fig. 1, is 100 mm to 100 mm and the top area is 50 mm to 50 mm. In the specimens, nine of these unit cells are placed next to each other to create a 3×3 core structure. However, before merging these cells into a single part in the CAD model of the specimen, four of them are flipped over. The height of a single cell is 10 mm, which means the core thickness is 20 mm from top to bottom. After merging, fillets with 5-mm radius of curvature are introduced and an outer frame is added as shown in Fig. 1. Lateral dimensions of the parts (in x and y directions) are 340×340 mm. Shell elements are generated through the surface. Additionally, 3D circular bars are created as rigid parts. A model of 3-mm-thick rubber band is also created between the rigid bars and the face sheets using 3D deformable solid elements.

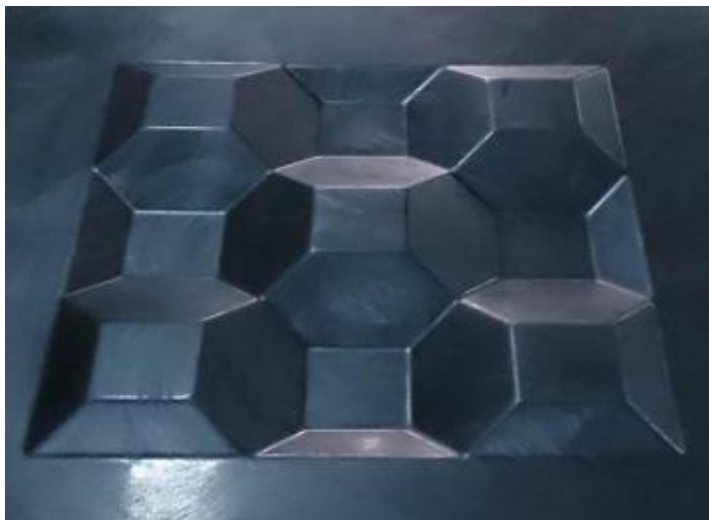
Fig. 2. The lacquer coated mold for the core.

Sandwich composite specimens used in the tests are produced by vacuum infusion process (VIP). Both the core and the face sheets of the sandwich structure are composite laminates themselves. A properly cleaned thick glass is used to manufacture two face sheets and a three dimensional mold is used for the core. The mold shown in Fig. 2 is made of RenShape® modeling board. Separately consolidated core and face sheets are bonded to each other by applying ARALDITE® 2000+ adhesive. They are held under press for at least 12 h in order to obtain high bonding quality.

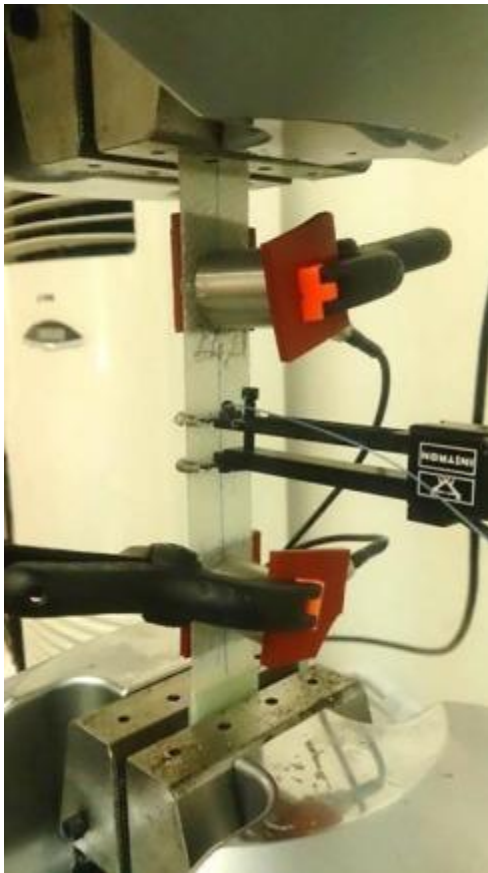
Fig. 3. The tension test setup.

ASTM D3039 standard test procedure is followed to determine the in-plane tensile properties of the laminated composite material. The tension tests are performed by applying displacement controlled loading with the rate of 2 mm/min using INSTRON 8801 servo-hydraulic testing machine. A proper specimen installation is followed by placement of a clip-on extensometer and acoustic emission (AE)

transducers using clamps as shown in Fig. 3. The tests are repeated five times for each layup in accordance with ASTM D3039 test procedure.

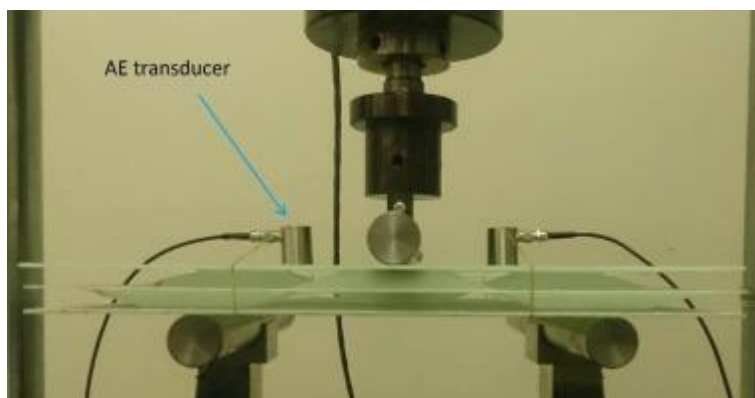
Fig. 4. The three-point-bending test setup.

Three sandwich plates are tested using the three-point bending test setup shown in Fig. 4. The core and the face sheets are quasi-isotropic; their stacking sequence is $[0/45/-45/90]_s$. The thicknesses of the core and the face sheets are measured to be 1.40 mm and 1.20 mm, respectively. Although the same stacking sequence is used for the core and the face sheets, the thickness is different because of the difference in the mold shapes. The three circular bars, used in the fixture, have a length of 300 mm and a diameter of 26 mm. For specimen 1, both of the AE sensors are placed on the top and no rubber bands are placed between the bars and the specimen. For specimens 2 and 3, one of the AE sensors is placed on the top and the other is placed on the bottom of the specimen and rubber bands are placed between the bars and the specimen. The test is displacement controlled with the rate of 3.55 mm/min.

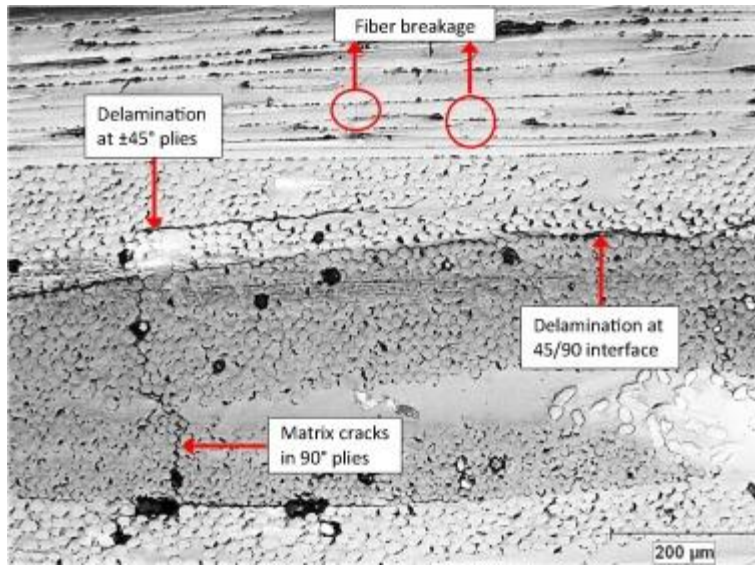
Fig. 5. Damage modes observed in a micrograph of $[0/45/-45/90]_s$ laminate.

progression in various types of quasi-isotropic laminates during tension tests using AE monitoring, digital image correlation (DIC) and in-situ edge microscopy techniques. According to the findings of these studies, damage initiates in quasi-isotropic laminates in the form of matrix cracks in 90° plies followed by delamination at $45/90$ interfaces. Then, internal cracks develop and delaminations occur in $\pm 45^\circ$ plies; finally, fibers in 0° plies break. Accordingly, ply failures in the quasi-isotropic specimens are also assumed to occur in the same sequence in the present study. As for the specimens with $[0/90]_2s$ lay-up sequence, it is well known that 90° plies fail first, then 0° plies. In-situ optical observation techniques are not used during the tension tests. Ply-failure load levels are determined considering the changes in the load-displacement diagram as well as the AE signals.

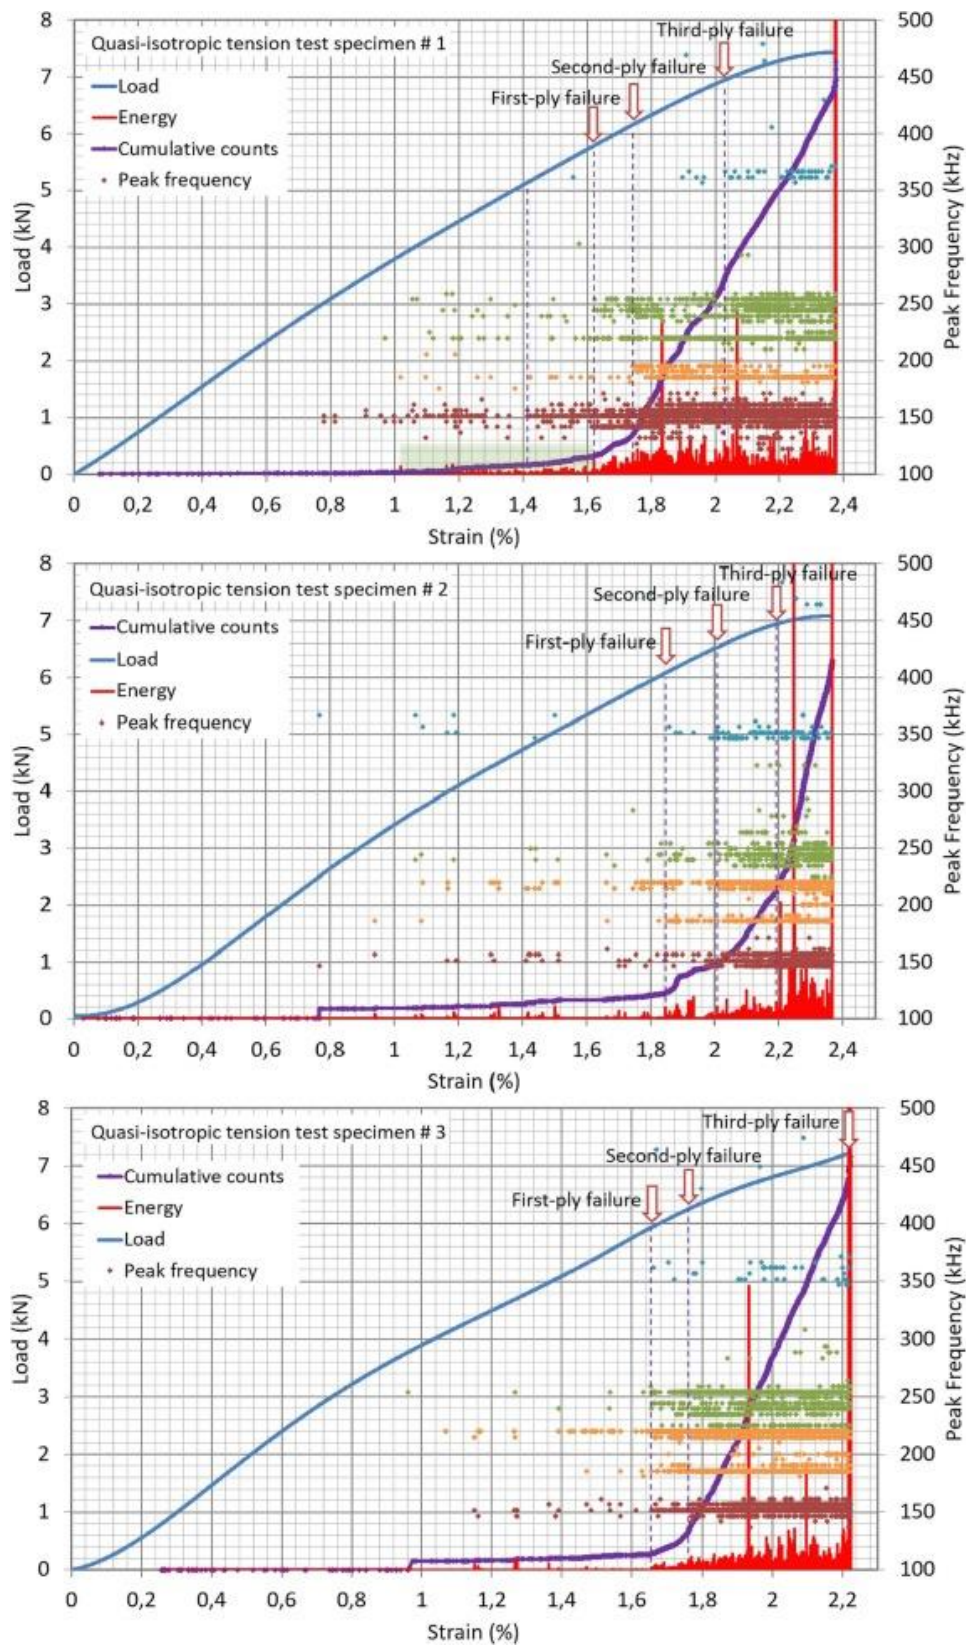
Fig. 6. The peak frequency distribution, the energy levels, and the cumulative counts of the AE hits and the load vs. strain for quasi-isotropic tension test specimens with layup configuration [0/45/-45/90]_s.

Fig. 6 shows the peak frequency distribution as well as the energy levels of AE hits for three quasi-isotropic specimen, $[0/45/-45/90]_s$, together with the load-strain curve. Energy parameter is the time integral of the absolute signal voltage [57]. High-energy peaks may be associated with damage; but they may also occur due to sliding of transducers and grips over the specimen. Relative magnitude of energy depends on the type and extent of damage as well as the distance between the transducers and the location of damage. Its magnitude also depends on the value of energy reference gain, which is selected as 20 dB. The relative magnitudes of the energy peaks, not the absolute magnitudes, are taken into consideration in the AE analysis; for these reasons, energy values are not shown in the graph, they are just scaled to fit the graph. The graph also includes the cumulative count, which is the total number of AE hits up to a certain time. The shape of the curve, not the value of the cumulative count, is important in interpreting the signal. For this reason, it is also scaled to fit the graph; so all the data can be seen in a single figure. Noise in AE monitoring is an important problem. In order to filter background noise produced by the servo-hydraulic test machine or another source, threshold level for amplitude is adjusted to 45 dB. Still, this does not totally eliminate noise signals. Additionally as a post-processing filtering, only signals consecutively recorded by each sensors with a difference in recording time less than 10 ms are kept; others are not taken into consideration. This filtering method does not change the general AE distribution, but provides a more clear view of signals associated with damage modes.

For the second specimen, the first, second, and third-ply failure loads are estimated to be 6.08 kN, 6.64 kN, and 6.96 kN, respectively. For the third specimen, these failure loads are estimated to be 5.94 kN, 6.25 kN, and 7.2 kN, respectively. As discussed before, 90° plies fail first during tension loading of [0/45/-45/90]_s specimens, then +45/-45 plies, finally 0° plies. Considering that there are conflicting reports regarding correlation of peak frequencies and amplitudes with damage modes and the fact that ply failures may involve activation of a number of damage mechanisms, these ply-

failure load levels are determined considering the changes in the slope of load-deflection curve and the changes in AE signal characteristics. As discussed before, common features of the AE signals at these failure load levels are change in the slope of the cumulative-counts curve, increase in the energy levels of the subsequent hits, formation of new frequency bands or increase in the density of the existing frequency bands. For the third specimen, the third-ply failure load is taken the same as the ultimate load level, considering that initiation and progression of fiber damage in 0° plies would certainly cause a considerable decrease in stiffness, but no significant degradation occurs in the stiffness of the third specimen before the ultimate load level is reached. Two more quasi-isotropic specimens are tested and their load-displacement curves and AE signal characteristics are found to be similar to those shown in Fig. 6.

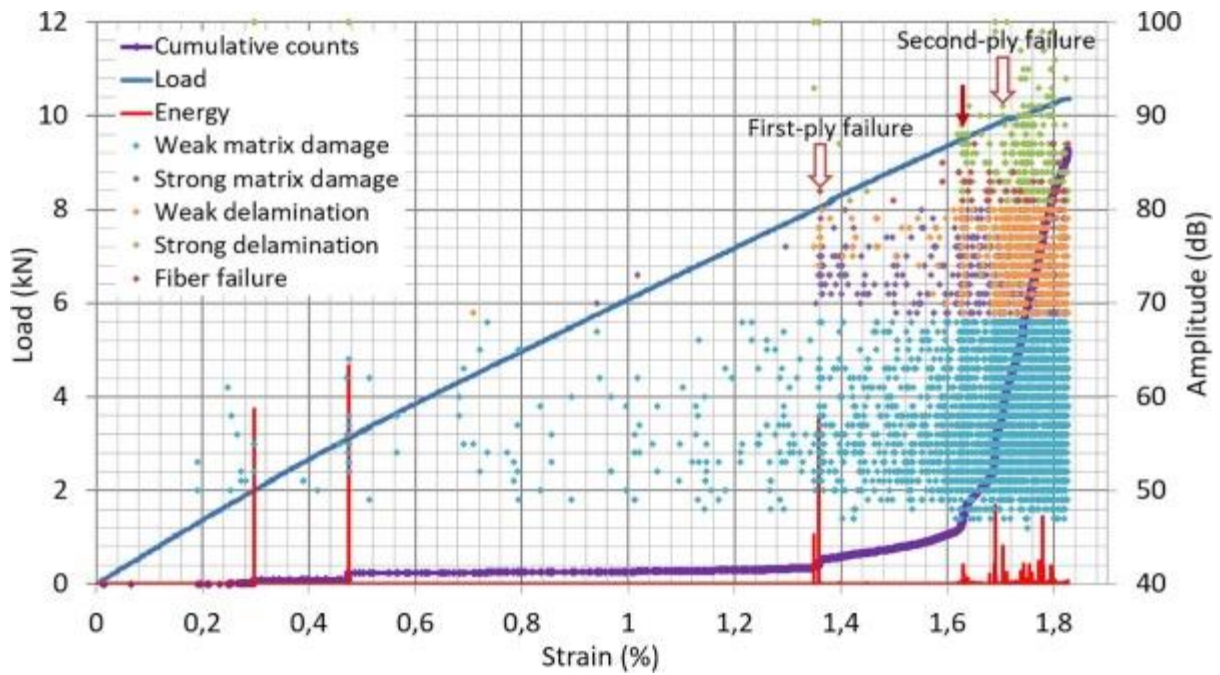
Fig. 7. The amplitude distribution, the energy levels and cumulative counts of the AE hits and the load vs. strain curve for a cross-ply tension test specimen with layup configuration [0/90]2s .

Another AE parameter that researchers try to relate to damage mechanisms in composites is amplitude of acoustic signals. Fig. 7 shows the amplitude distribution, the cumulative counts as well as the energy levels of the AE hits for a cross-ply specimen, $[0/90]_2s$, together with the load-strain curve. The load at fracture exceeds 10 kN. The load carrying capacity of cross-ply specimens is higher under uniaxial loads along the fiber direction in comparison to quasi-isotropic specimens as expected. At strain levels about 0.3% and 0.47% corresponding to 2 kN and 3 kN load levels, signals are detected with very high energy levels. Until 2 kN, load-strain curve is constant; between 2 kN and 3 kN, a slight degradation in stiffness occurs. There is also jump in the cumulative-counts curve. For these reasons, these signals are attributed to damage in the specimen. However, this is not considered as a total lamina failure. This load level is too low to have a matrix failure in 90° plies and the density of the hits remains low up to 6 kN. This damage is believed to arise due to stress concentration from stitches. This test is repeated five times; the same behavior is observed at these load levels in all the specimens. In order to find the source of the signals and the change in the slope of the load-displacement curve, one need to stop the test after 3.0 kN load is exceeded, cut the specimen, and examine micrographs of the sections. When the load exceeds 8.0 kN, the transducers start to detect high numbers of AE signals with a high energy peak. Significant increase in the density of registered hits clearly indicates initiation of substantial damage within the laminate, besides a new band of AE hits, 68–80 dB, is activated. The cumulative-counts curve exhibits a jump and a considerable increase in slope. Accordingly, the first-ply failure load level can be taken as 8.0 kN. Based on the findings of Asokan et al. [44], and the distribution of AE hits in Fig. 7, 48–68 dB amplitudes can be assumed to indicate weak matrix damage; 68–80 dB amplitudes with a duration shorter than 300 μs may indicate strong matrix damage; 68–80 dB amplitudes with a duration longer than 300 μs may indicate weak delamination together with strong matrix damage; amplitudes higher than 80 dB with a duration longer than 300 μs may indicate strong delamination; amplitudes higher than 80 dB with a duration shorter than 300 μs may indicate fiber breakage. Accordingly, matrix failure occurs at 8.0 kN in 90° plies. At 9.5 kN, the AE instrument starts to detect hits with amplitudes higher than 80 dB. These are believed to be generated by delaminations at the interface between 0° plies and 90° plies. Previous studies [52], [53] showed that 90° plies failed due to transverse cracks followed by delaminations using in-situ edge microscopy. Transverse matrix cracks in 90° layers propagate with the increase in load until they reach the interface; then they may trigger delaminations along the interface. The slope of the cumulative-counts curve significantly increases at this point, indicating high volume of subsequent AE signals. The second-ply failure occurs at 9.9 kN due to fiber breakage. There is a considerable change in the slope of the load-displacement curve after this. Besides, AE signals with amplitudes greater than 90 dB are recorded. The density of the AE signals in the 80–90 dB range increases. Accordingly, fibers in 0° plies start to fail beyond this level, which soon consumes the load carrying capacity of the laminate.

As a summary of the tension test results presented in Fig. 6, Fig. 7, Table 3 gives the ply failure load levels and the corresponding failure modes for [0/45/-45/90]s and [0/90]2s laminates.

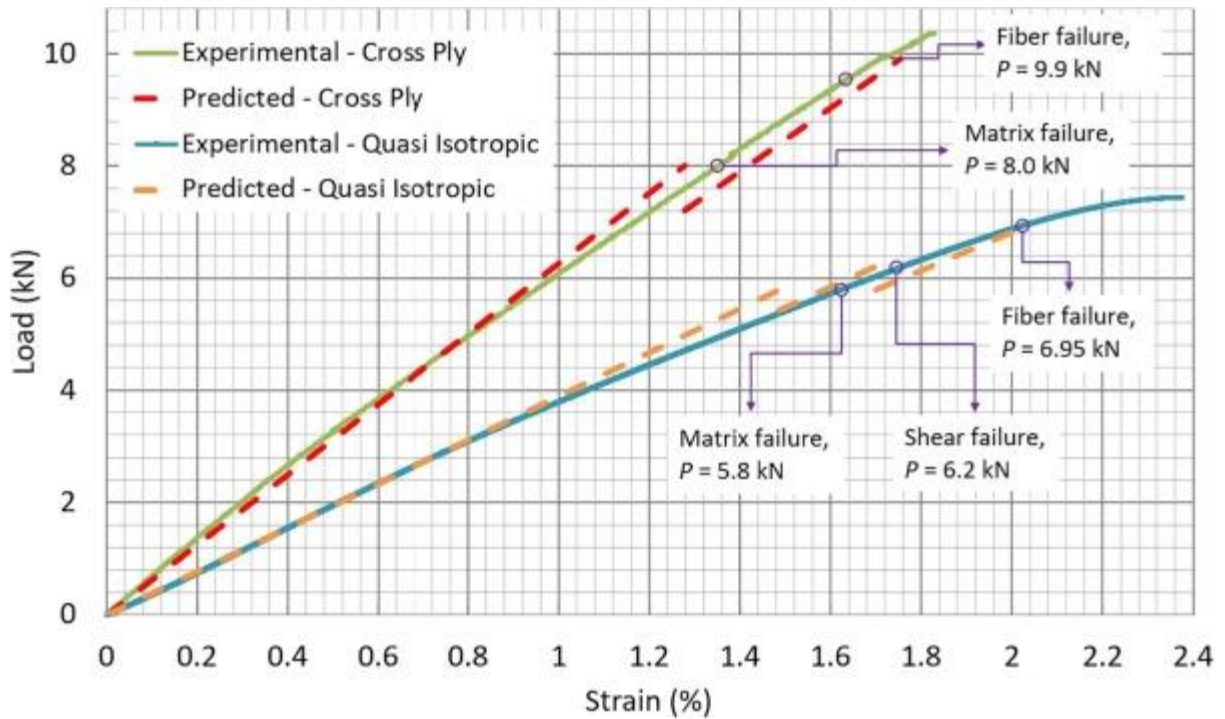
Fig. 8. Experimental load-strain curves of tension test specimens with cross-ply, $[0/90]_2s$, and quasi-isotropic, $[0/45/-45/90]_s$, layup configurations and the curves predicted by the progressive damage model.

In order to obtain the strength properties of unidirectional E-glass reinforced epoxy, a progressive damage model based on the classical lamination theory (CLT) and the maximum stress failure theory is developed that simulates the mechanical behavior of the tension test specimens. Fig. 8 shows a comparison between the experimental load-strain curves of cross-ply and quasi-isotropic tension test specimens and the curves predicted by the progressive model using the stiffness properties given in Table 4. The predicted curves almost coincide with the initial linear portions of the empirical curves. This shows that the values for the stiffness properties of unidirectional lamina given in Table 4 provide a good fit. As discussed before, ply-failure load levels are determined based on the AE data. First-ply failure of the quasi-isotropic specimen with $[0/45/-45/90]_s$ layup configuration occurs at 5.8 kN due to matrix failure in 90° plies. The normal stress transverse to the fibers in the failed layers is 69 MPa according to CLT. Hence, the transverse tensile strength, Y_t , is taken to be 69 MPa. Above this load level, the matrix dominated stiffness components, E_2 , ν_{12} , ν_{21} , and G_{12} , of 90° plies are degraded by multiplying their values given in Table 4 by a degradation factor, d_m ; so their subsequent values after damage occurs in 90° plies are d_mE_2 , $d_m\nu_{12}$, $d_m\nu_{21}$, and d_mG_{12} . The fibers are assumed intact. The value of d_m is chosen as 0.2 so that the slope of the predicted curve would be about the same as that of the experimental curve at this load level, and the two curves would become closer. The second-ply failure occurs due to shear failure in 45° plies at 6.2 kN. The shear stress in these plies in the principal material coordinates is found to be 40 MPa. Accordingly, in-plane shear strength, S , is taken as 40 MPa. The matrix dominated stiffness properties, E_2 , ν_{12} , ν_{21} , and G_{12} , of 45° plies are then degraded by taking the value of the degradation factor, d_m , as 0.6. The progressive damage model assumes that ply-failures occur suddenly with total lamina failure; for this reason, the predicted curve is piecewise linear with sudden drops in load level. Actually, total failure of a layer does not occur suddenly; on the contrary, the damage in the specimens occurs progressively as can be seen in Fig. 8; the slope of the load-displacement curve of the tension-test specimen continually decreases beyond the linear range. Gradual decrease in the slope indicates that damage in a layer occurs progressively leading to progressive degradation in stiffness. The model uses the maximum stress theory, which neglects the interaction between intra-laminar failure modes. However, the resulting error is assumed tolerable for the purposes of engineering design. Third-ply failure occurs at 6.95 kN due to fiber failure in 0° plies. Normal stress along the fiber direction in 0° plies calculated with the degraded stiffness values for 90° and 45° plies is 612 MPa. Accordingly, the longitudinal tensile strength, X_t , is taken as 612 MPa. The same procedure is applied to cross-ply specimens, $[0/90]_2s$. Matrix failure in 90° plies occurs at 8.0 kN, then fiber failure follows at 9.9 kN. d_m is again taken to be equal to 0.2 after matrix failure. According to these load levels, the transverse tensile strength, Y_t , and the longitudinal tensile strength, X_t , are found to be 64 MPa and 532 MPa, respectively. These values are about 10% lower than the ones calculated for the quasi-isotropic specimens. Because quasi-isotropic layup configuration is used in the sandwich plates and the cross-ply tension specimens sustain premature damage, the values of strength parameters calculated for quasi-isotropic tension test specimens are

adopted in the finite element modeling of the sandwich plates. The above-mentioned procedure is also applied to the other two quasi-isotropic tension-test specimens and their strengths in principal material directions are found. Then, average of the values estimated for the three quasi-isotropic specimens is calculated. As for the compressive strengths, the data reported in the technical data sheet of the resin material [54] are considered. According to the data sheet, the epoxy reinforced with 16-ply 8H satin woven glass fabric with 43% fiber content has a compressive strength about 10% lower than its tensile strength. Bibo et al. [58] and Laustsen et al. [59] reported the value of compressive strength for epoxy reinforced with non-crimp glass fabrics slightly lower than the tensile strength. Considering also that the compressive strength of the epoxy material is larger than its tensile strength as given in Table 2, longitudinal and transverse compressive strengths of unidirectional glass-epoxy laminate, X_c and Y_c , are taken as -600 MPa and -120 MPa, respectively. Considering that initial failure of sandwich specimens are observed to occur due to tensile stresses not compressive stresses, tests are not conducted to determine the compressive strengths of the material, instead their values are estimated based on the values reported in the literature. Estimated and calculated strength properties of unidirectional E-glass-epoxy lamina are given in Table 5.

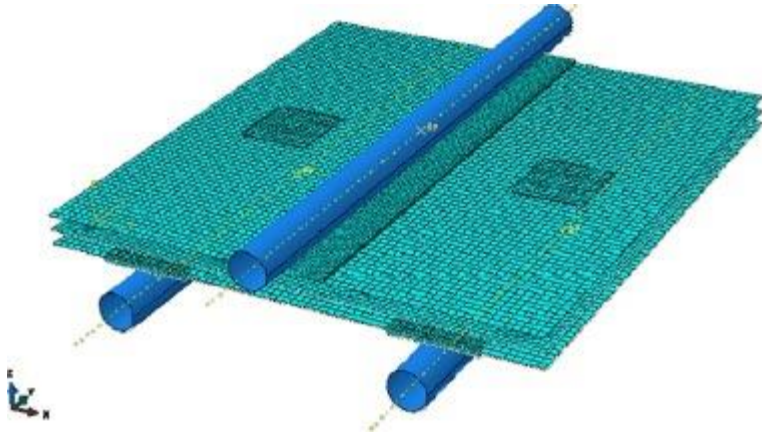
Fig. 9. FE model of three-point bending and meshed assembly.

In the face sheets, S4R elements are generated. S8R element type is used in the core part. A mesh convergence study is conducted in order to decide the element size. While applying the same loading conditions, different element sizes are selected. Based on the mesh convergence analysis, the element sizes for the core and sheets are selected as 4 mm and 5 mm, respectively. Fig. 9 shows the meshed assembly.

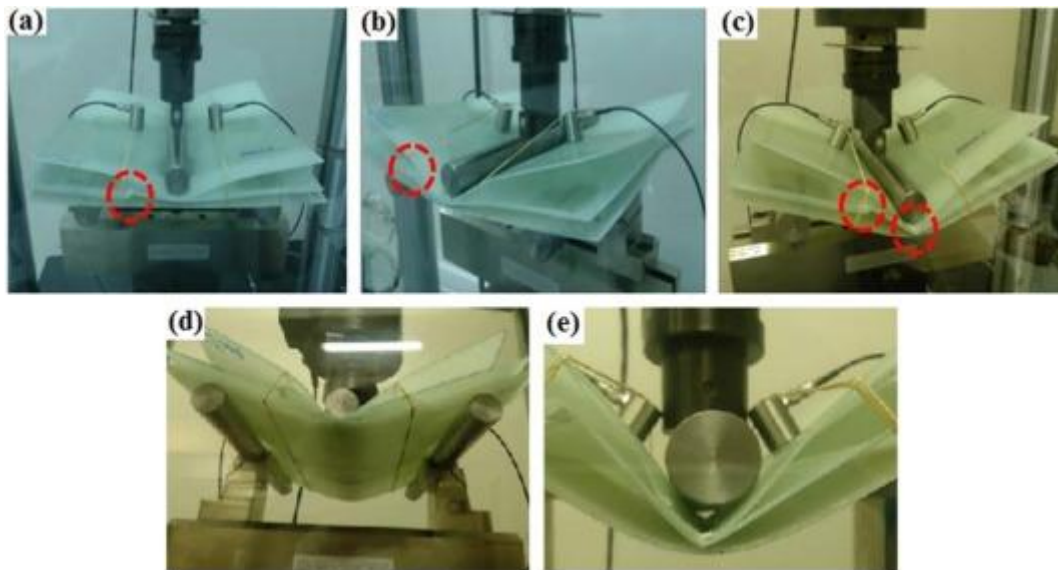
Fig. 10. Three-point bending test depicted at the stage when the deflection of the middle bar is (a) 17 mm, (b) 28 mm, (c) 52 mm (d) 52 mm, and (e) 66 mm.

The tests are planned such that the load is increased until significant damage occurs in the plates. As seen in Fig. 10, the plate keeps its integrity although the deflection at the end of the experiment exceeds almost three times its total thickness. At the peak load, the measured reaction force reaches 4820 N; the corresponding deflection is measured as 5.70 mm. For the other two specimens, the peak loads are measured to be 4430 N and 4650 N. Because 3-mm-thick rubber bands are placed between the bars and the specimens in the other tests, the corresponding displacements are larger, which are measured as 8.62 mm and 9.67 mm. Rubber bands are used in the other tests to reduce stress concentration and prevent generation of AE signals due to sliding between the bars and the specimen. It should be noted that characteristics of AE signals obtained in tension tests and three-point bending tests are different. There are several reasons for this. First, there is a thin adhesive layer between the core and the top and bottom plates. Damage in adhesive layers is a different failure mode. Under three-point bending, compressive stresses also develop, which trigger different

In specimen 3, the load-displacement curve is also linear up to 3.0 kN; after that it is nonlinear with reduced stiffness. Below 4.1 kN, the AE signals have low energy levels; therefore, they may be due to micro cracks or noises. Above 4110 N, a hit with a high energy level is detected accompanied by rapid increase of AE signals; correspondingly a jump appears in the cumulative-counts curve. This implies that considerable damage occurs at 4110 N. This is considered as the first-ply failure load. After the ultimate load level is reached, discontinuities in the curve are observed accompanied by high numbers of AE hits with frequencies indicating occurrence of all failures modes. Peak frequencies in 180–200 kHz band, which may indicate delamination, are detected in significant number only after the ultimate load level is reached. After that, the load bearing capacity of the plate decreases; however it can still withstand loads above 2.5 kN until the deflection reaches 18 mm (Fig. 10a).

In both specimens, a new frequency band around 50 kHz appears after 10.4-mm deflection, following ultimate failure. Each time a large number of AE signals with peak frequencies around 50 kHz are recorded, a sudden drop occurs in the load carrying capacity of the specimens. That is presumed to be due to fracture of the skin or core plates as shown in circles in Fig. 10.

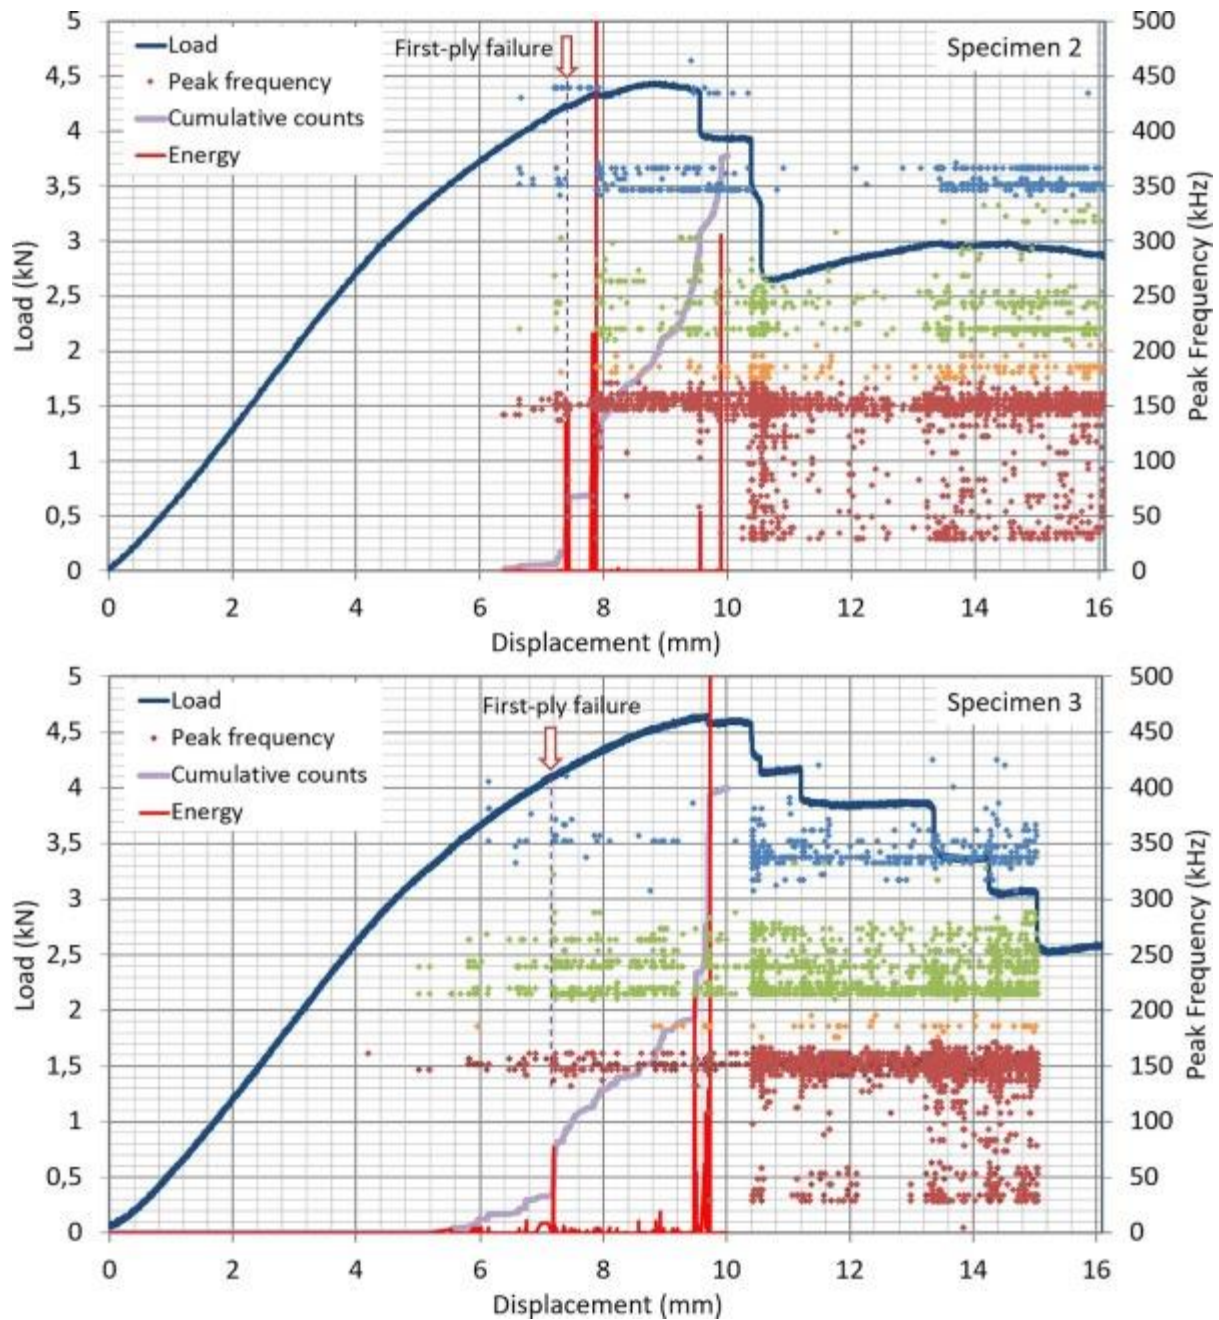
Fig. 11. Peak frequency distribution of AE hits and load vs. displacement for two sandwich specimens under three-point bending, together with energy levels and cumulative counts of the AE hits up to 10 mm displacement.

Fig. 11 shows the change in the load with the displacement of the middle bar and the corresponding peak frequency of the AE data for specimen 2 and specimen 3. The figure also shows the energy levels and the cumulative counts up to 10 mm displacement, beyond which energy and the cumulative counts take too high values to show them in the graph. These values are not shown in order to see clearly the signals in the early stages of damage progression, considering that the focus of this study is the initial damage behavior, not post failure behavior. Cumulative counts are scaled to fit the graph. The energy values are not scaled; their absolute values are shown in the secondary axis.

In specimen 2, the load-deflection curve is linear up to about 3.0 kN; then the slope of the curve continuously decreases until the ultimate load level is reached. The initial decrease in the stiffness can be attributed to geometric nonlinearity due to local buckling of core faces as will be discussed. In the later stages, progressing damage also contributes to degradation in stiffness. AE instrument starts detecting signals at 3.8 kN, but with low energy levels. These may be due to micro damage in the material or noises resulting from sliding of AE transducers. At 4240 N, AE hits with relative high energy levels are detected; there is a corresponding jump in the cumulative counts and a slight discontinuity in the load-deflection curve. Accordingly, the first-ply failure load is taken to be 4240 N. When the load level reaches 4330 N, signals with very high energy levels are obtained; the density of the frequency bands including 350–370 kHz increases; the load-deflection curve exhibits a

considerable change in slope. All these indicate that significant damage occurs in the specimen including rupture of fibers. After that the ultimate load is soon reached, beyond which the load carrying capacity of the specimen decreases.

the failure mechanisms. The nonlinearity in the load-displacement curve of the sandwich plate (Fig. 11) may partially be attributed to local buckling beside damage progression. As mentioned before, the first-ply failure loads of specimen 2 and specimen 3 are 4240 N and 4110 N, respectively (Fig. 11). The predicted failure load is about 5% lower. The correlation between numerical and empirical results is considered to be satisfactory.

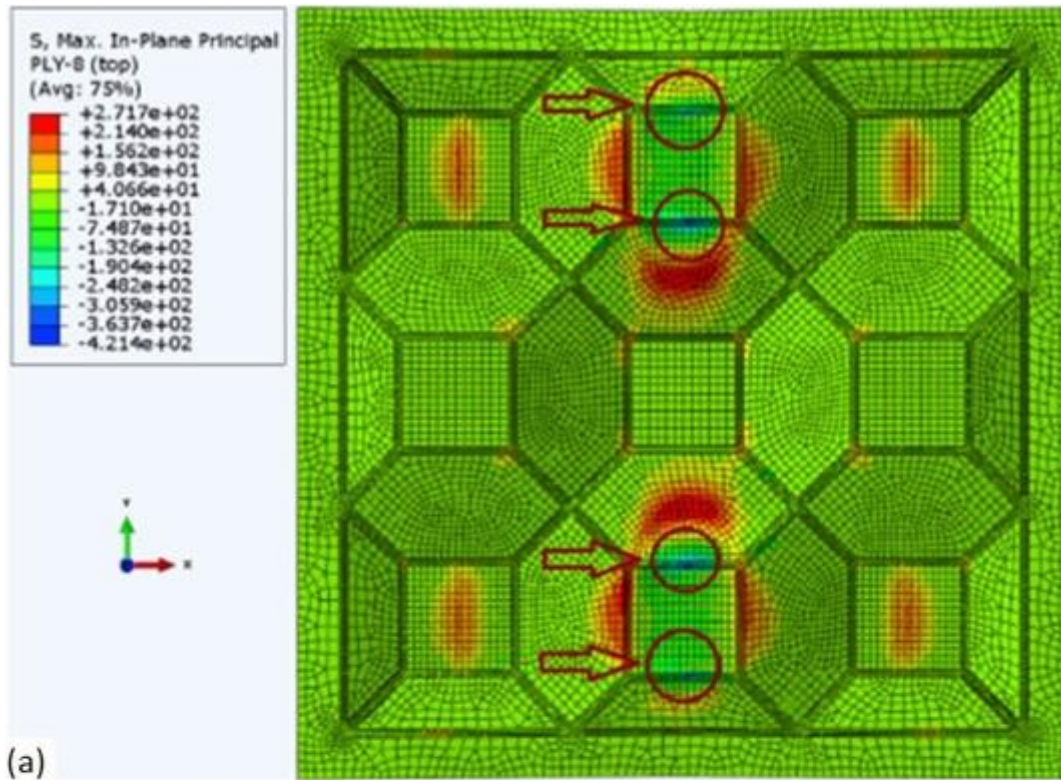
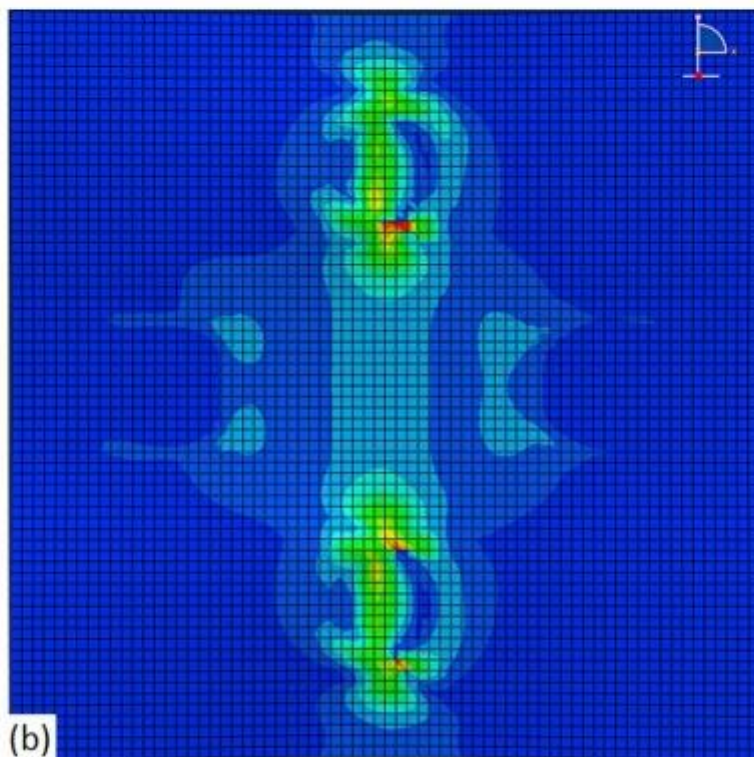
Fig. 12. The maximum in-plane principal stress state distribution in (a) the core and (b) the face sheet corresponding to 8-mm displacement.

In order to verify the finite element model, the loading conditions up to the peak load level are considered. In order to predict the failure behavior after the plate undergoes substantial damage, a progressive model has to be developed, which is not within the scope of this study. The structural model with rubber bands is subjected to deflection controlled loading by setting the displacement of the middle bar, U3, to 8 mm. The maximum in-plane principal stress state in the top layer of the core and top face sheet are shown in Fig. 12. The fibers are oriented in the x direction. There is stress concentration at the edges of the core, where initial damage is expected to occur.

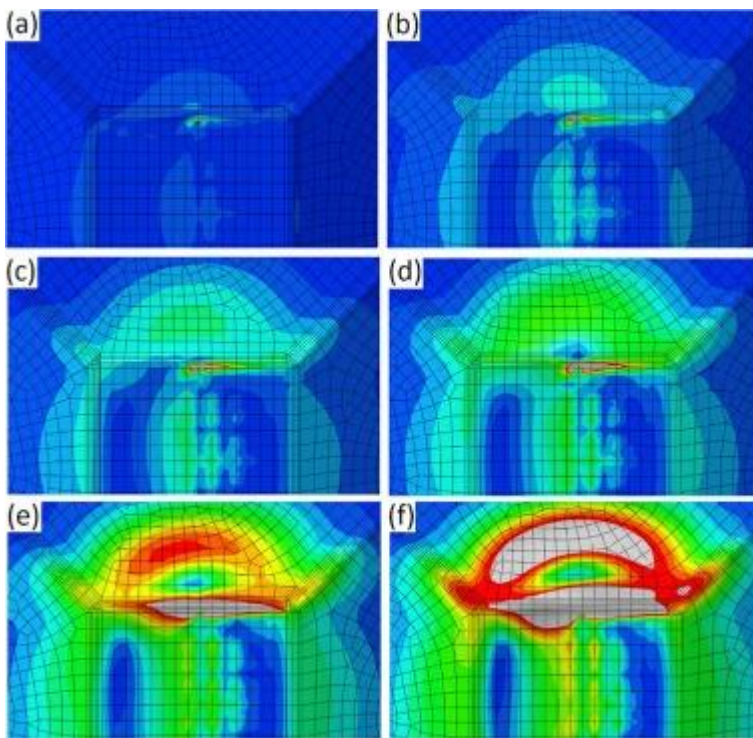
Fig. 14. The failure index distribution for the top layer of the core at when the deflection of the middle bar is (a) 1.6 mm, (b) 3.2 mm, (c) 4 mm, (d) 4.8 mm, (e) 6.4 mm, and (f) 8 mm.

Fig. 13 shows Tsai-Hill failure index distribution in the middle layer of the core, where fibers run in the y-direction. Fig. 14 shows the change in the failure index in the critical region as the load is increased. The edges of the core naturally cause stress concentration. In Fig. 13, Fig. 14, 1.0 is

selected as the upper limit. In the grey regions, the failure index is above 1.0, therefore they are assumed to have failed.

The first specimen is cut into two pieces for inspection (Fig. 15a). Comparing the distribution of the failure index predicted by the FE model in Fig. 14 and the failed regions in the specimen shown in Fig. 15b, one may infer that the agreement between the model predictions and the test results is quite satisfactory. Significant damage occurs at the side walls of the unit cells in the core.

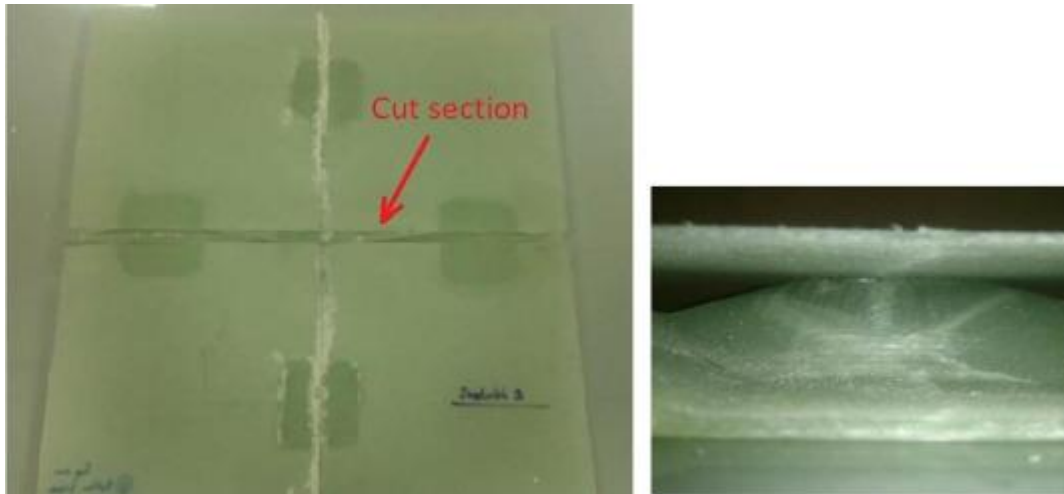
Fig. 15. (a) Specimen 1 cut into two pieces, and (b) damaged region in the core seen through the cut section.

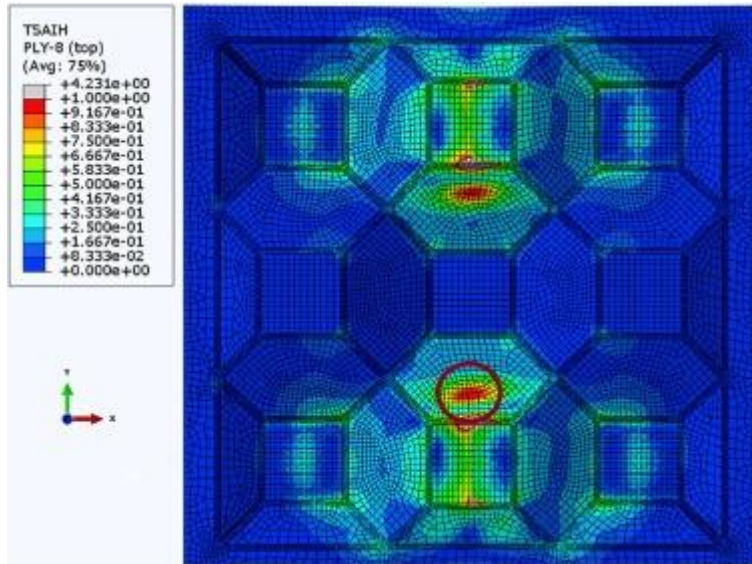
Fig. 16. Tsai-Hill failure index distribution corresponding to the predicted failure load (4590 N) and the initial failure location. Initial failure occurs in the encircled region.

A Python Script code is developed and an iterative study is conducted using Secant algorithm in order to estimate the failure load, at which the maximum failure index is equal to 1.0. If the regions with excessive stress concentration are included in the failure assessment, failure is predicted to occur when the deflection is 1.6 mm as shown in Fig. 14a; the corresponding reaction force on the middle bar is calculated as 1178 N. In that case, the FE model highly underestimates the failure load. Considering that the top surfaces of the cores are rigidly attached to the face sheets in the FE model, while in reality, the connection is not rigid and the edges of the glued region are not sharp, the predicted stresses in this region are expected to be more severe than the actual stresses both in the face sheet and the core. This is one of the reasons of underestimating the strength. Secondly, initial damage that occurs locally at stress concentration regions hardly affect the macro behavior of the structure. Because of these reasons, the regions with severe stress concentration are neglected in the strength assessment procedure. There are two cells of the core on the y-z symmetry plane which are directly attached to the top face sheet and there are two edges parallel to the x-direction for each cell, where stresses are locally high. Between the glued surfaces and the angulated core walls, the curved fillet regions exist. Tsai-Hill failure index values at all the elements on these four fillets and the first rows of the elements at the two sides of these regions are not taken into account. Similarly, the elements of the top face sheet which lie within the vertical projection of the neglected areas of the core are also not taken into account. Along the thickness of a single ply, three-integration points are defined. Accordingly, there are 24 sections in a single element for the model. Each section has four integration points since S8R is the selected element type. After six iterations, the algorithm finds that the initial failure occurs at the 24th section when the deflection of the middle bar is 6.02 mm. The 24th section is in the top layer of the core. In this layer, the longitudinal fiber direction is perpendicular to the axis of the middle bar. Corresponding reaction force is obtained to be 3961 N. For this loading condition, the distribution of the failure index on the top layer of the core is shown in Fig. 16. As indicated in the figure, the initial failure occurs at an angulated core wall. In the most critical element, where Tsai-Hill failure index is equal to 1.0, the transverse stress is 69 MPa, which is equal to the transverse tensile strength of the composite material, while the other stress components in principal material directions are much lower than their respective strengths. Therefore, one may conclude that the predicted first-ply failure mode is matrix failure. The FE model results reveal that tensile stresses develop in the top layer of the core in the critical region shown in Fig. 16, while compressive stresses develop in the bottom layer, which means that the wall of the core buckles outward. This implies that local buckling in the core is one of

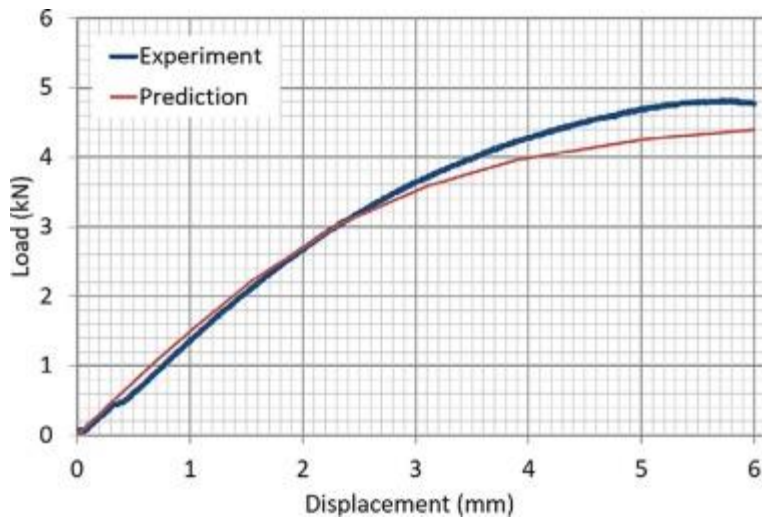
Fig. 17. Comparison of load vs. middle bar deflection curve predicted by the FE model and the one obtained by testing sandwich specimen 1, which does not include rubber bands (Fig. 4).

Fig. 17 shows the load vs. deflection curve predicted by the FE model and the curve obtained by testing sandwich specimen 1. In this test (Fig. 4), rubber bands are not used between the bars and the specimen; for this reason the ultimate load is reached with a lower displacement. The agreement between the results of the FE model and the actual mechanical response of the sandwich structure is acceptable. Even though linear material properties are used and progression of damage is not taken into account in the FE model, nonlinear mechanical response of the plate due to local buckling is predicted by the model. The difference between the predicted and measured curves can be explained by a number of factors: First, elastic moduli of the composite material in different directions are not directly measured; but evaluated based on the tension test results of quasi-isotropic and cross-ply laminates; for this reason there may be some errors. Secondly, elastic moduli in tension and compression are taken the same; but this may not be the case. Thirdly, the thickness of the core is taken in the FE model the same as the thickness of the face sheets (1.20 mm); actually it is measured as 1.40 mm. Although, the fiber content is the same and the elastic modulus of the matrix is small, this leads to some error. However, considering the experimental scatter, the error in the predictions is small. Table 6 gives a comparison of the first-ply failure and peak load levels predicted by the FE model and the test results.
