The conservation of modern architectural heritage buildings in Turkey: İstanbul Hilton and İstanbul Çınar Hotel as a case study

Ayşe Durukan Kopuz^{a,*}, Ahmet Bal^b

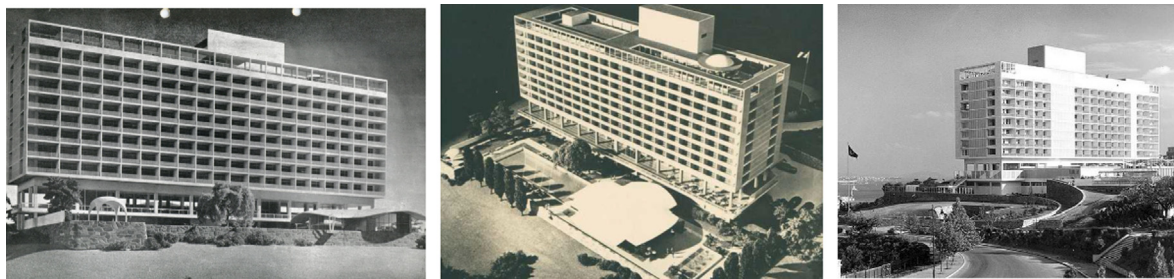
Fig. 2. Old photos of Hilton Hotel, just after building two/three years later [32-34].

geous reinforced concrete skeleton on the facade which were reminiscent of Le Corbusier [28]. The building defined the aesthetic standards of 1950s architectural language, which became a symbol as International style of American influence [29]. The location of the hotel must have been chosen so carefully that it has a magnificent Bosphorus scenery from the top a hill, standing on its pilots with a rectangular box. Fig. 2 shows the photos of hotel just after it was built.

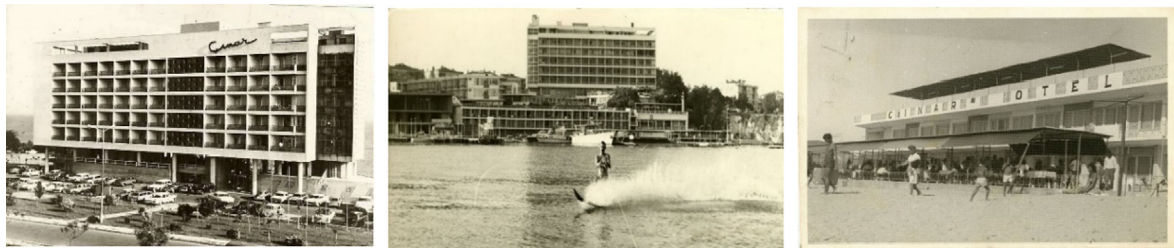
Fig. 7. Old photos of Cinar Hotel [40-42].

As stated in newspapers, it was the biggest hotel after Hilton Hotel with 150 rooms, swimming pool and other facilities [38] (Figs. 7, 8). Because of its location on Yesilköy beachside, initial project was made up through beach facilities with a main block. The garden as a continuity of restaurant was used a terrace that stretches to the sea. On the ground floor, there is reception, the bazaar and Bade bar, while there are resting, tea and ceremonial halls on the mezzanine floor, a restaurant, pavilion and kitchen, laundry room and so on in the basement, which is on the same floor with the garden [37]. Fig. 9 shows the architectural plans of floors respectively.

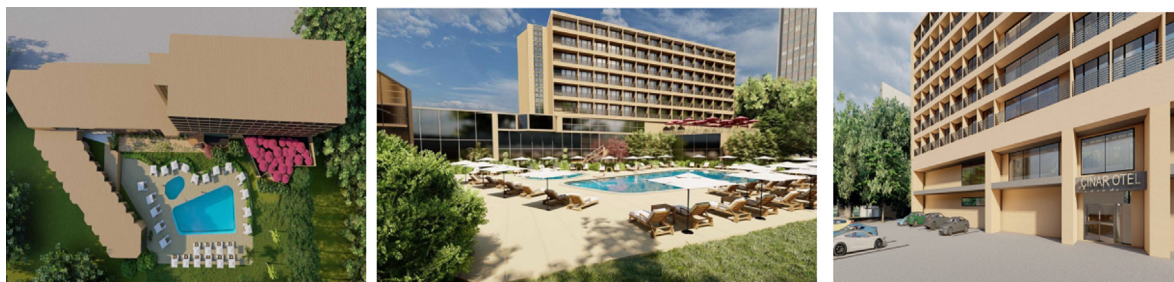
Fig. 8. Architectural renders (site scenery from top and front facades) of hotel.
